Article in *Journal of Asian Architecture and Building Engineering* · January 2015

Performance Study of an Eight-story Steel Building Equipped with Oil Dampers Damaged During the 2011 Great East Japan Earthquake

Part 1: Structural Identification and Damage Reasoning

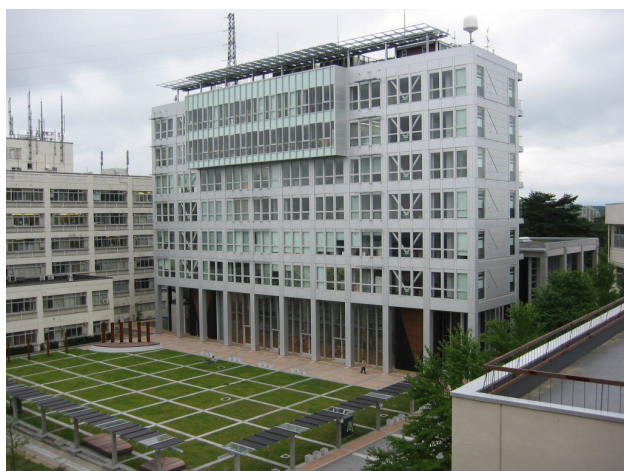
The eight-story Administration Building on the main campus of the Tohoku Institute of Technology (in Sendai, Japan) was constructed in 2003 and has a length of 48 m, a width of 9.6 m, and a height of 34.2 m, as shown in Fig.1. The superstructure is a steel-frame structure with precast concrete slabs, and the one-story basement is reinforced concrete. This steel building was designed to satisfy the Japanese Earthquake Resistance Code for School Buildings without any control equipment. To verify the effectiveness of the newly developed oil damper at the Tohoku Institute of Technology and improve the structural earthquake resistance capability, 56 sets of dampers were installed, as shown in Fig.2. Each floor has eight sets of oil dampers, which are connected with the use of V-type braces between the adjacent floors, as illustrated in Fig.3. The first floor and the second floor were merged to form a large space with a height of 8 m.

Fig.1. Administration Building of the Tohoku Institute of Technology

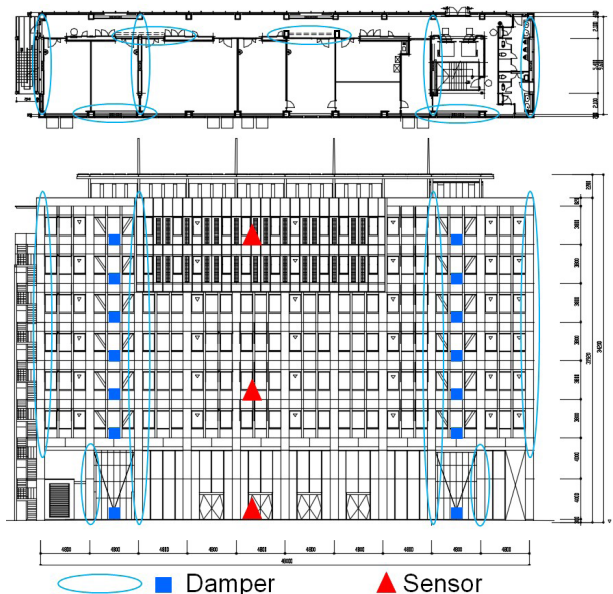
Fig.2. Allocation of Oil Dampers

A monitoring system is installed in this building. Two-direction accelerometers were located on the first, fourth, and eighth floors to record the dynamic responses of the structure; the location of accelerometers is shown in Fig.2. To examine the performance of oil dampers in real application, load cells with a strain meter and displacement transducers were installed on the dampers on the first and eighth floors in both directions to obtain the restoring force and displacement of the dampers during earthquakes.

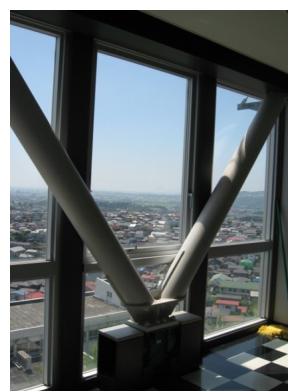
Fig.3. Brace of the Oil Damper

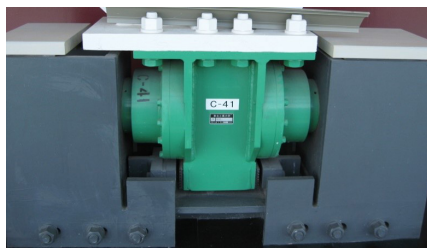
Kawamata *et al.* (Funaki *et al.*, 2001, Kawamata *et al.*, 2000) proposed a new type of oil damper that is composed of a cylinder and a pair of pistons. The gaps between the cylinder (oil container) and pistons are sealed with viscoelastic polymer, as illustrated in Figs.4. and 5. The sealing scheme relaxes the manufacturing

Fig.4. Intact Oil Damper

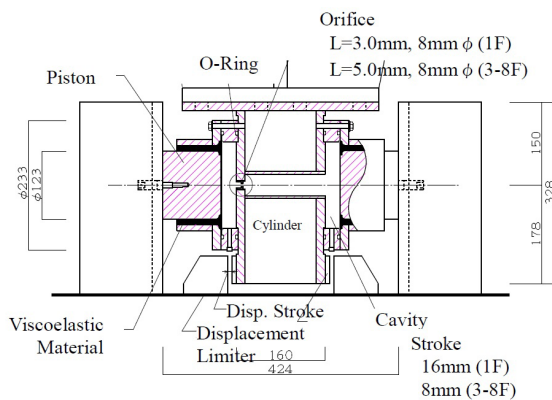
Two types of oil dampers are installed in the Administration Building to investigate the performance of the oil dampers in real application. An oil damper is 424 mm wide and 328 mm high with different piston diameters and orifice specifications for the 1F floor and 3–8F floors. These two types of dampers also have different stroke limits (the displacement extent of piston in one direction), which are 16 mm for 1F dampers and 8 mm for 3–8F dampers, respectively. The pistons are fixed with the U-type abutment on the floor and the central cylinder is attached to the V-type brace. The moving direction of pistons is horizontal. Therefore, the damper displacement is the same as the interstory drift, without considering the deformation of the rigid V-type braces. The central cylinder moves back and forth along the axis of the pistons within the stroke limit when the interstory drift occurs because of ground motion. An extra cushion limit is prepared (8 mm for 1F dampers, 5 mm for 3–8F dampers) to protect the central cylinder from colliding with the abutment.

Fig.5. Dimension of the Oil Damper

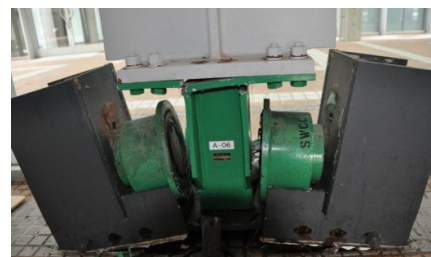
During the 2011 Great East Japan Earthquake (also known as the 3/11 Earthquake), all eight sets of dampers on the first floor were destroyed, as shown in Fig.6. The damper pistons on both sides were torn from the central cylinder (oil container). The U-type abutments fixed on the first floor were opened wider as the pistons ran out of the stroke limit and cushion limit, and pushed against the abutments. Sixteen sets of dampers on the third and fourth floor had severe oil leakages, because the sealing viscoelastic polymer had worn out. However, the mechanical parts of the oil dampers remained undeformed.

Fig.6. Damaged Oil Damper and Abutment

During the 3/11 Earthquake, the dampers on the first floor were damaged severely and the abutments were wrecked. The damage description indicates that both the stroke and cushion limits of the pistons seemed to have been reached, and the central cylinders were pounded against the abutment repeatedly until the abutment connection and oil dampers were broken. Therefore, the displacement limit state is assumed to be the damage scenario of the oil dampers. In this study, the damage process of oil dampers was replayed based on identification and simulation.

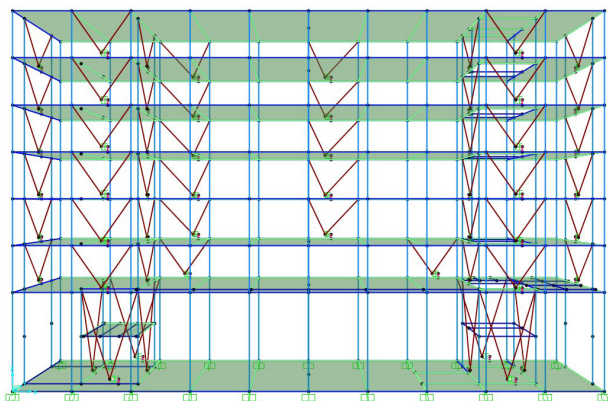
For the nonlinear dynamic analysis, the numerical model of this steel building was established by using finite element analysis software SAP2000, as shown in Fig.7. The superstructure was modeled and fixed on the

Fig. 7. FEM Model of Building with Dampers

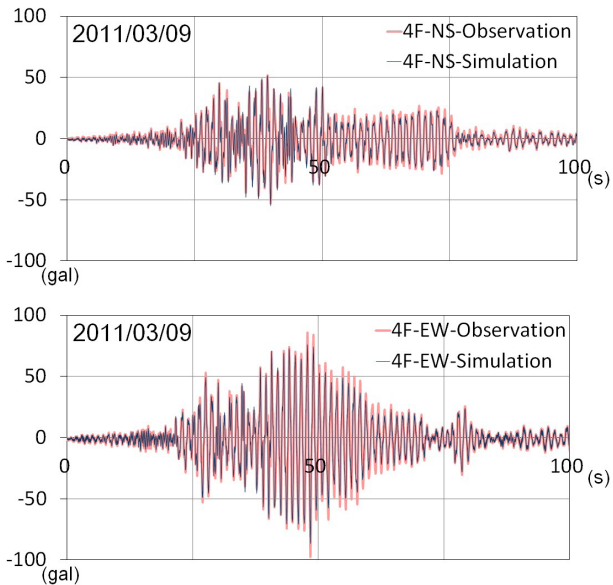
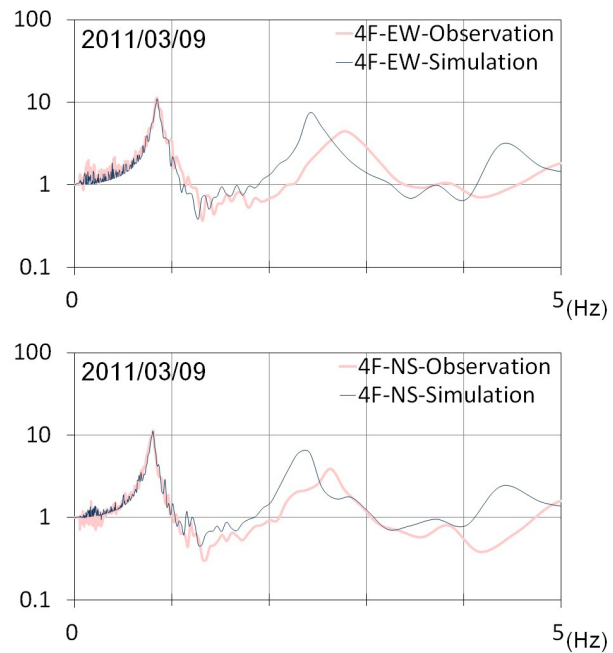
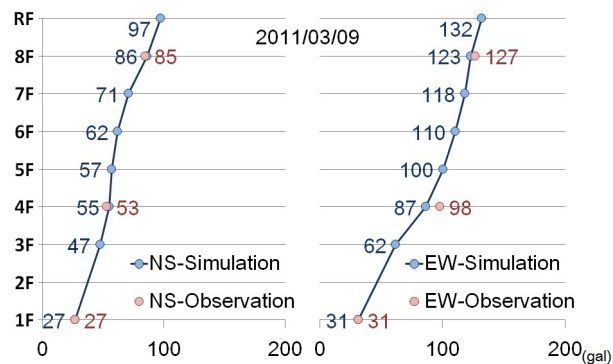
The building equipped with dampers experienced an earthquake two days before the main shock. The ground motion of March 9, 2011 had a PGA of 32 gal in the EW direction and a PGA of 26 gal in the NS direction. The two-step identification procedure was performed to build the numerical model for nonlinear dynamic analysis. Fig.8.(a) shows the acceleration responses on the fourth floor of observation and the simulation in both directions. Fig.8.(b) demonstrates the transfer functions between the fourth and the first floors in the frequency domain. Fig.8.(c) compares the maximum acceleration on each floor of observation and simulation. The acceptable agreement between the measured and simulated responses verified the identified numerical model.

Fig. 8. Comparison of the Observation and Simulation (March 9, 2011)

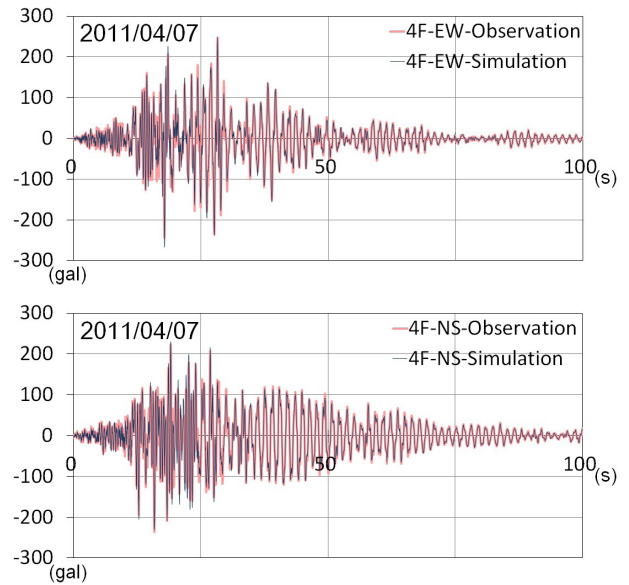
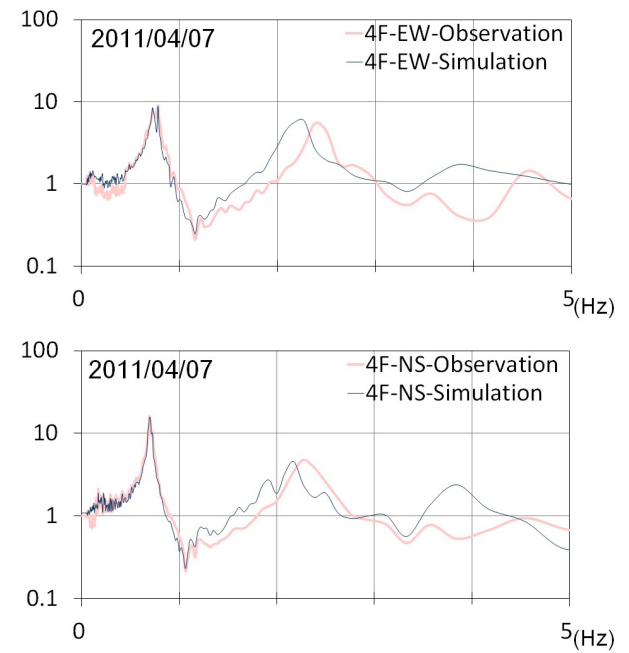
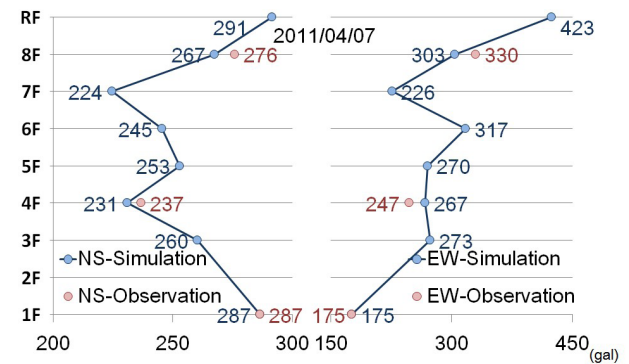
Fig. 9. Comparison of the Observation and Simulation (April 7, 2011)

Fig.9. shows the acceleration responses that were recorded and simulated in the time domain of the fourth floor as well as the transfer functions in the frequency domain and the maximum acceleration of each floor.

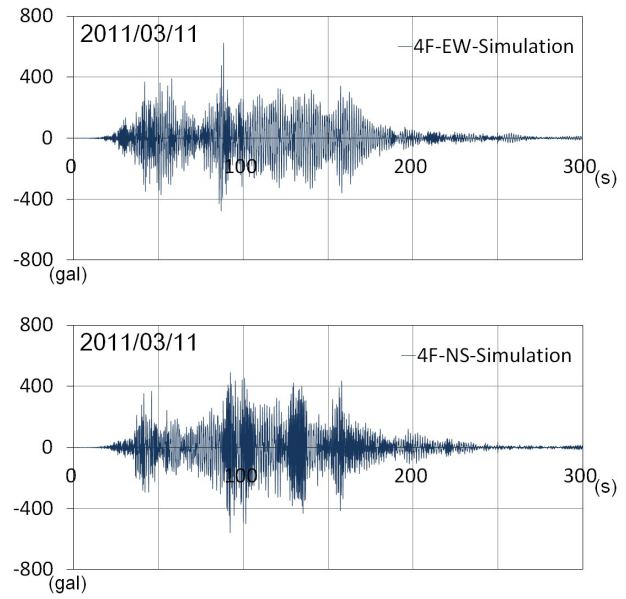
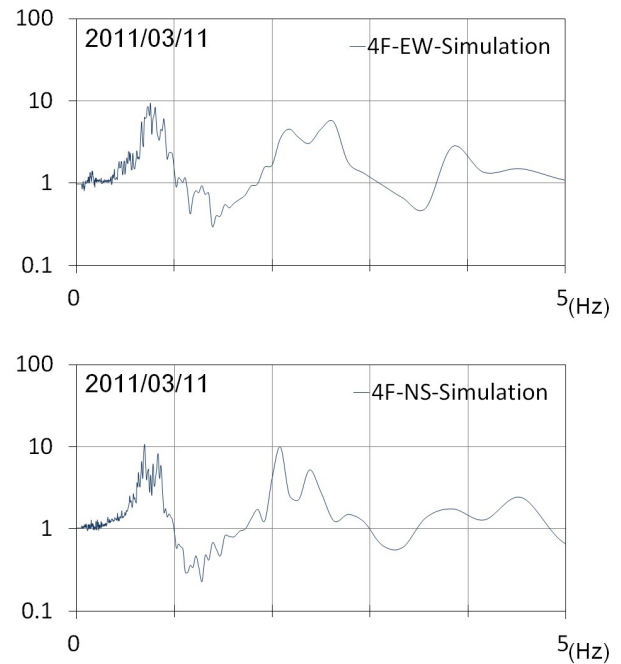
The acceleration responses on the fourth floor simulated for the main shock are plotted in Fig.10.(a). The transfer functions between the fourth floor and the ground excitation are plotted in Fig.10.(b).

Fig.10. Simulated Results of Earthquake (March 11, 2011)

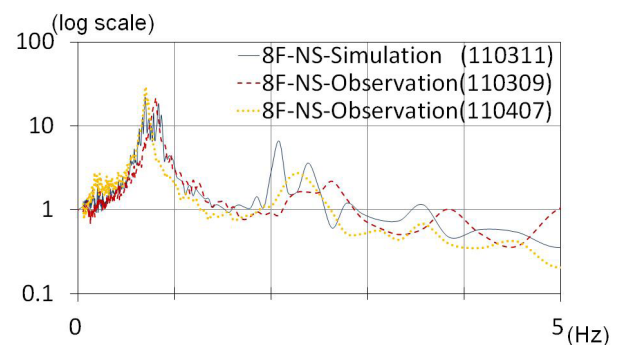
The transfer functions from the first floor to the eighth floor in the NS direction are shown in Fig.11. for a comparison between the dynamic properties of the foreshock, the main shock, and the aftershock. The first period of aftershock is larger than that of foreshock because of the absence of the dampers on the first, third, and fourth floors. The maximum magnification factor in the first period of the aftershock is higher than in the other two cases. These facts reveal the effectiveness of the dampers in adding damping as well as suppressing building vibration.

Fig.11. Comparison of the Transfer Function

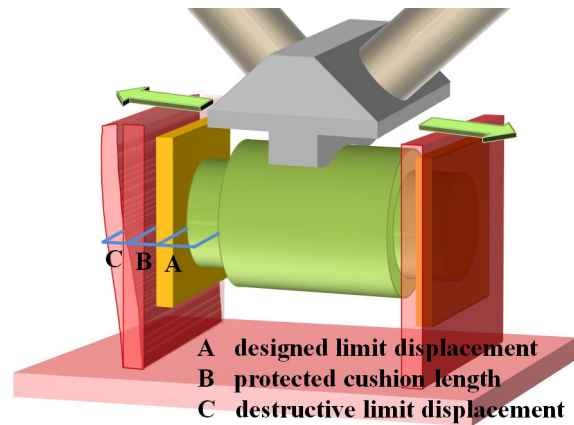
According to the design book, the designed stroke limit displacement of the damper for the first floor is 16 mm (pink line in Fig.13.) and 8 mm for the third to eighth floors. In addition to damper protection, a cushion limit was also designed with 8 mm (red line) for the first floor and 5 mm for the third to eighth floors. The damper reaches the displacement limit state and the cylinder pushes against the abutment when the stroke and cushion limits run out. If the cylinder does not retract and continues to push against the abutment, the relative piston-cylinder velocity drops to zero. Thus, the restoring force of oil dampers becomes zero, and the V-type steel brace and the abutment on the floor carry the resistant force caused by restraining the interstory drift beyond the stroke and cushion limits. Once the dampers reach the destructive limit displacement, as depicted in Fig.12., the accumulated deformation energy is abruptly released to break the abutment connection and oil dampers. However, the difficulty lies in determining the destructive limit displacement of the abutment.

Fig.12. Diagrammatic View of the Damper's Limits

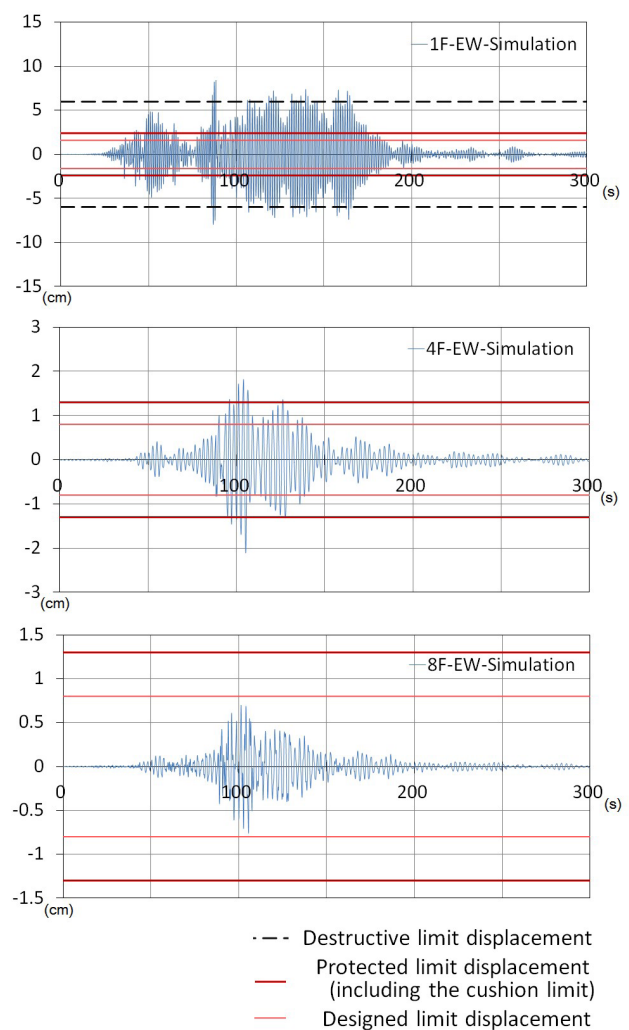
Fig.13. Displacement of Dampers During the 3/11 Earthquake

limit of other floors (2.6 for the fourth floor). With this normalized index applied to the first floor, the destructive limit displacement was determined to be 59.8 mm, which is shown as black dashed lines in Fig.13. The simulated interstory drift of the damper on the first floor in the EW direction on March 11, 2011 is plotted in Fig.13. The dampers of the first floor were most likely destroyed in about 90 seconds during the 3/11 Earthquake.

The main cause of the damper failure was the insufficient stroke range of pistons. The total allowable moving range of oil dampers was 24 mm for the dampers on the first floor in one direction (the sum of the 16 mm stroke limit and 8 mm cushion limit). Thus, the interstory drift angle of the first floor was 0.3% when the damper reached the displacement limit. Furthermore, the elastic limit of the interstory drift angle in the Japan Steel Building Code is 0.5% for minor earthquakes. The authors can infer that the original design of this administration building intended to use oil dampers to control structural responses to minor earthquakes while the structure responds elastically. However, the unprecedentedly intense earthquake caused large interstory drift, which the oil dampers could not withstand and consequently broke the dampers.
