Dynamic Properties of Conventional Beam-Column Timber Structure Under Successive Damage

Abstract

Keywords: conventional beam-column timber structure; natural frequency; numerical simulation; modal analysis; damage

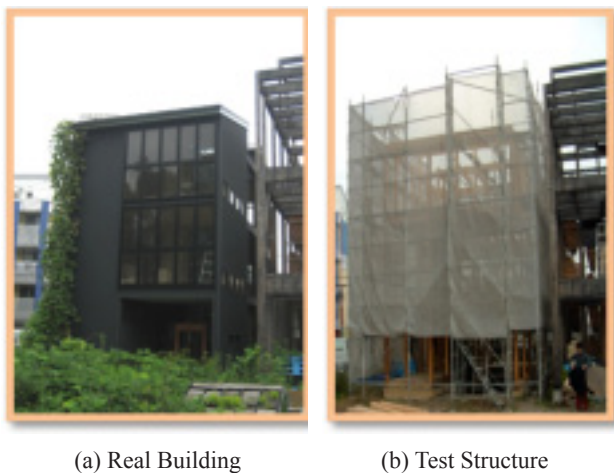
Fig.1. Test Structure On-site

are shown in Fig.1. Fig.1. (a) shows the exterior view of the real beam-column residential building, while (b) illustrates the structure for testing. Fig.2. shows the typical arrangement of the structure for testing, in which (a) shows the elevation while (b) and (c) depict the plan views. The sectional dimensions of all beams and columns were standardized at 120x240mm and 120x120mm respectively and were made from spruce, and mortised together with a tenon. Some of the joints were strengthened with steel fasteners, particularly

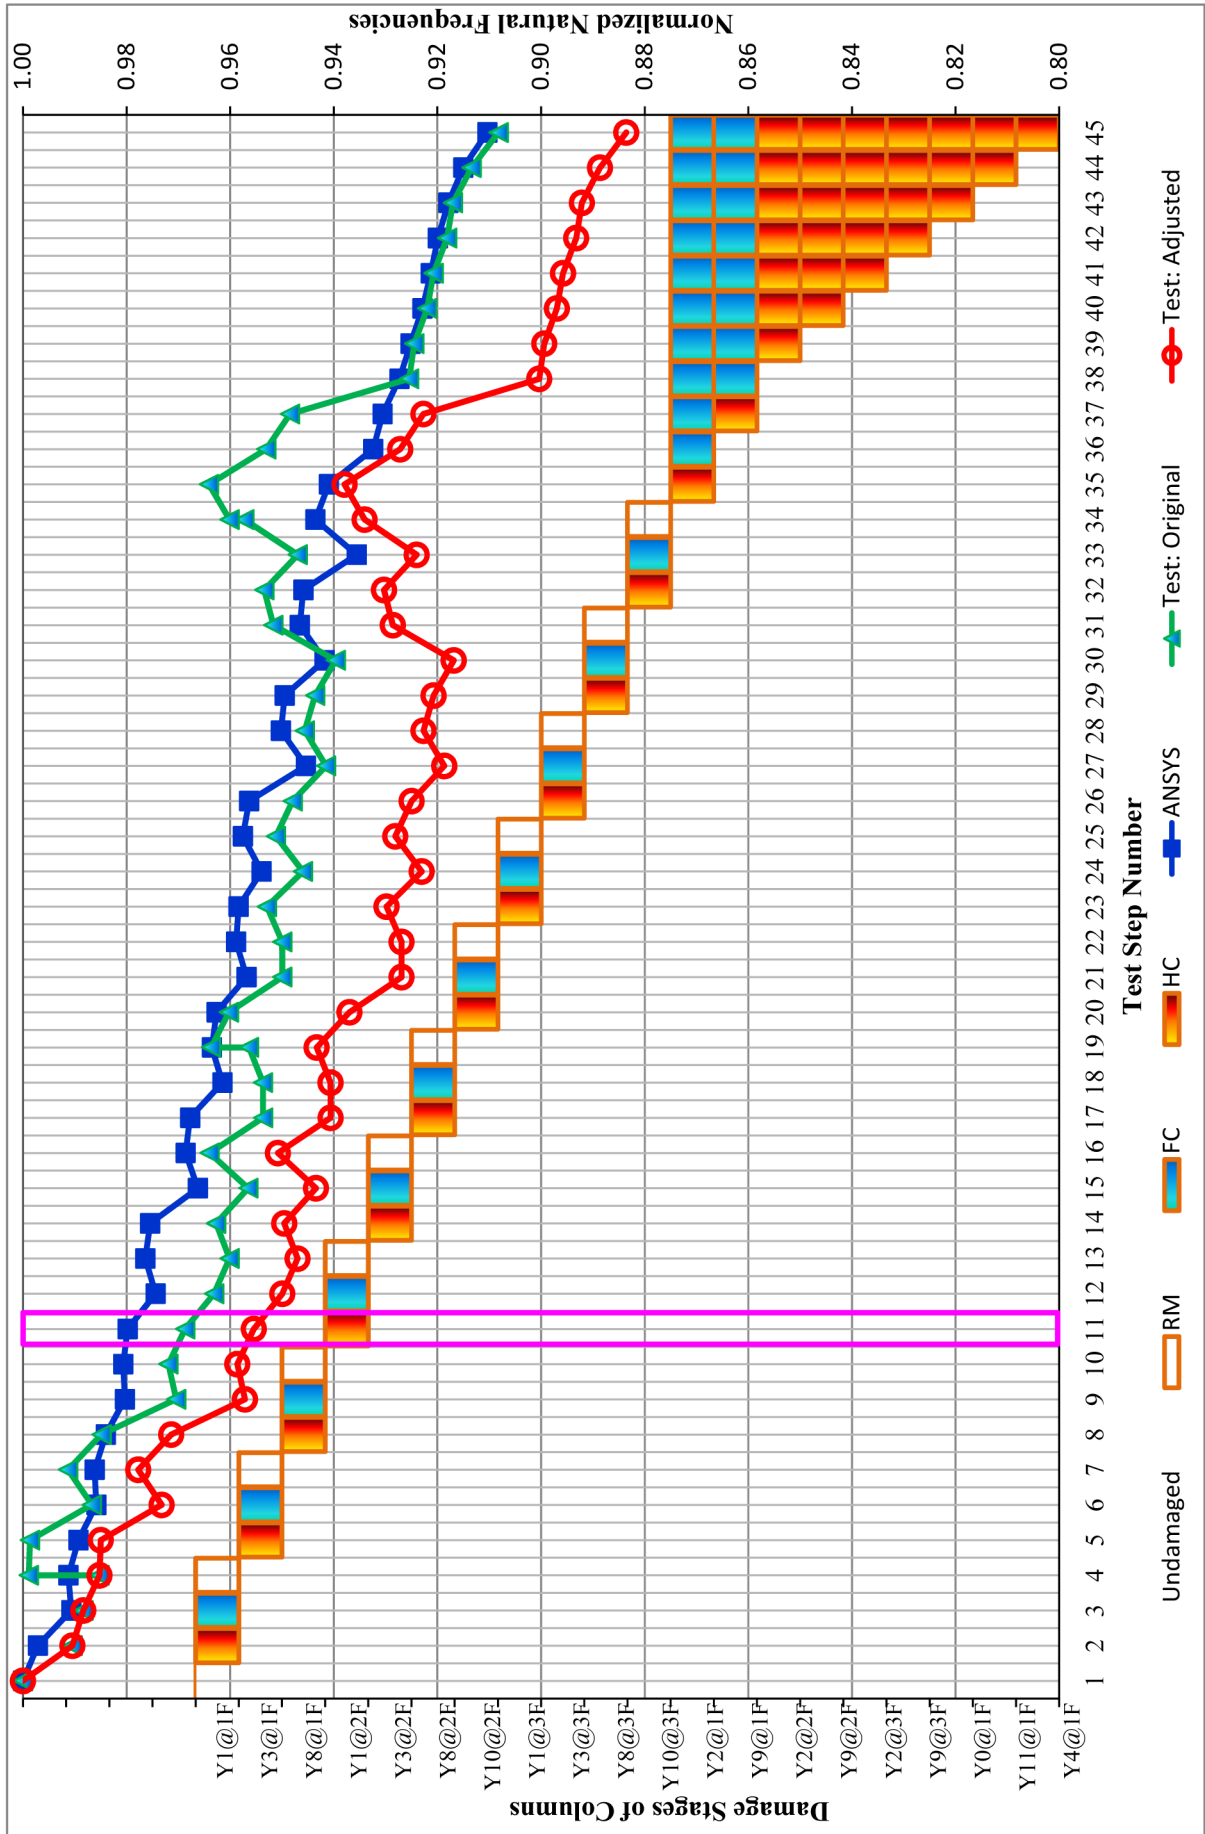
Fig.7. Damage Stages Versus Natural Frequencies

Fig.7. shows the normalized natural frequencies, for both the test structure and the ANSYS simulations, versus the damage stages. The lower part of Fig.7. shows the damage stages of the test structure for each step. Every rectangular bar in this plot represents a group of columns along the Y-axis at one story on the current test step, with different colors/textures denoting different damage stages. In order to be distinguished clearly between neighbor columns, those bars, which represent undamaged columns, are filled with three kinds of wood textures. Take test step 11 as an example, which is marked with a pink box in Fig.7. In the same figure, the rectangles filled from yellow to red denote those columns along the axis of Y1 on the 2F (denoted as Y1@2F, as shown in Fig.2.b) which had been half cut. Furthermore, columns along the axes of Y1, Y3 and Y8 on the 1F (above the gradient filled rectangle, here the authors use blanks to denote those columns which were totally removed for simplicity) were removed while the rest of the columns (filled with wooden texture, below the gradient filled rectangle) were undamaged. The examination of these plots reveals that more and more columns are damaged as the test step number increases, which results in gradual, more severe damage to the whole structure.

Three curves are shown in the upper part of Fig.7. Normalizing the natural frequencies of the test and ANSYS simulation, in Table 2., to the value of the first step, respectively, generates the green and blue

lines. Because two values of the same step such as step 4 were obtained in different conditions, the latter is adjusted to be equal to the former and the same adjustment was continued until the last test step. The adjusted values were also normalized to the first ones, and are depicted by a red line in Fig.7. considering that environmental factors such as temperature and relative humidity will influence the natural frequency of the timber structure (Xue, 2008). From a comparison of these curves, the following can be concluded,

beams with mortise or with joints strengthened by steel fasteners, referred to as 'columns'. In this study, eleven groups of posts were first tested with 33 steps, as shown in Table 2. and Figs. 6 and 7.

The comparison of natural frequency changes, induced by successive half-cutting of the column-bases, could be observed from the last 8 test steps, as shown in Fig.7. Good agreement between the numerical and experimental results can be observed.
